ARLINGTON COUNTY, VIRGINIA  
HISTORICAL AFFAIRS AND LANDMARK REVIEW BOARD  
APPLICATION FOR CERTIFICATE OF APPROPRIATENESS

Name of Historic District Maywood  
Address of Building 3501 21st Ave N , 22207

**3501 21<sup>st</sup> Ave North  
Devine Residence**

Emergency Request: to replace front stamped tin porch roof (3/12 slope) with standing seam metal roof

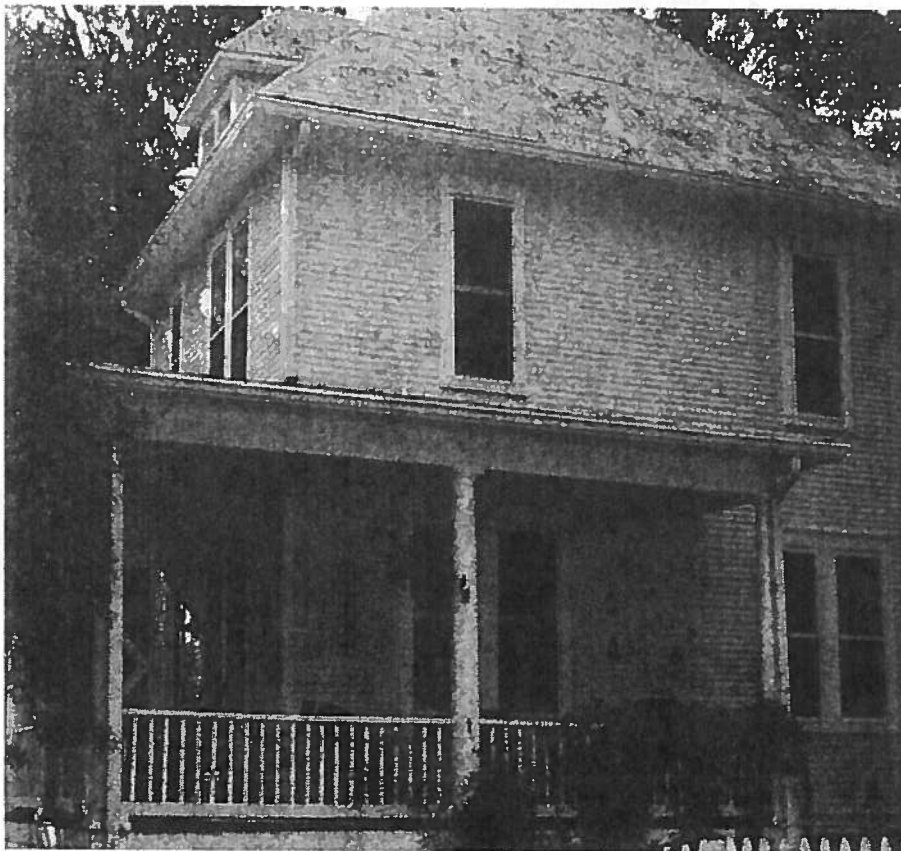
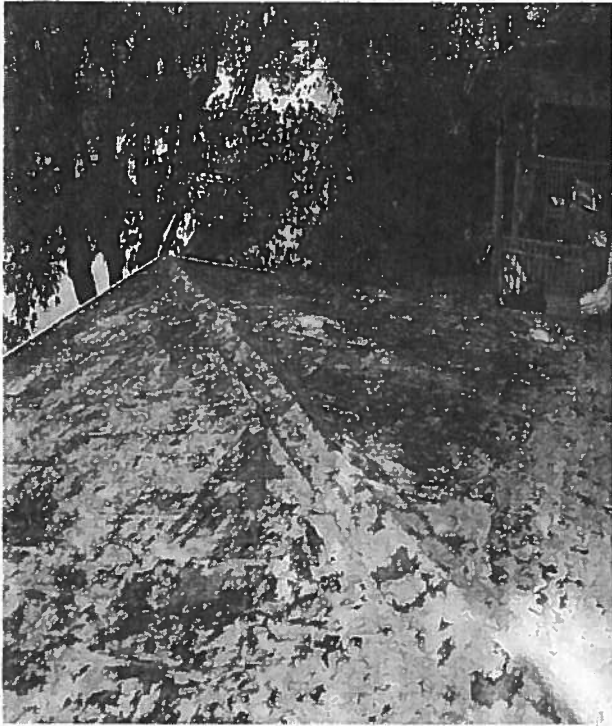
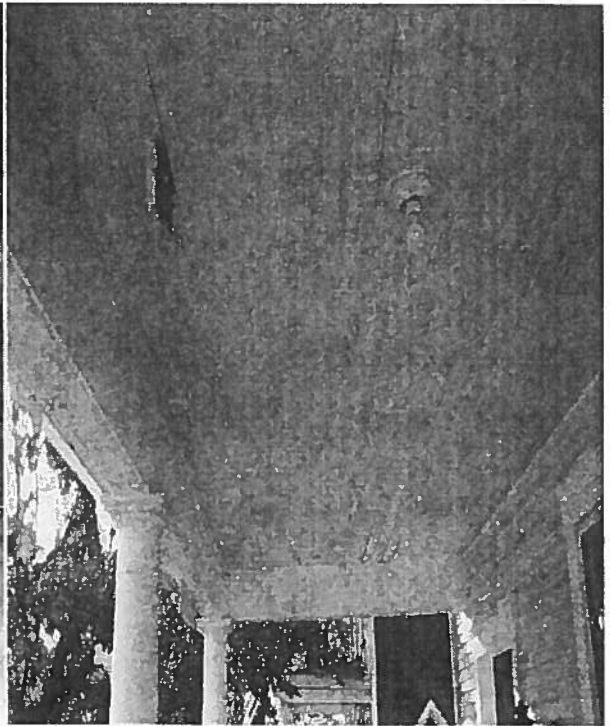
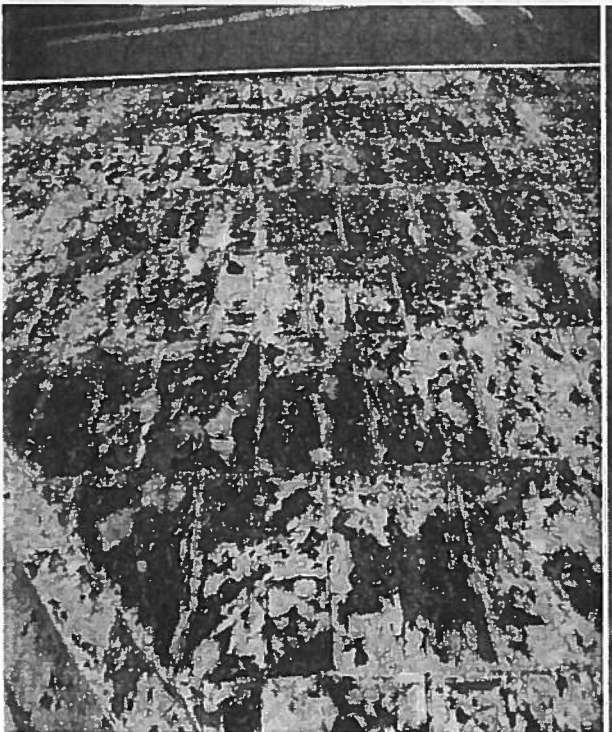
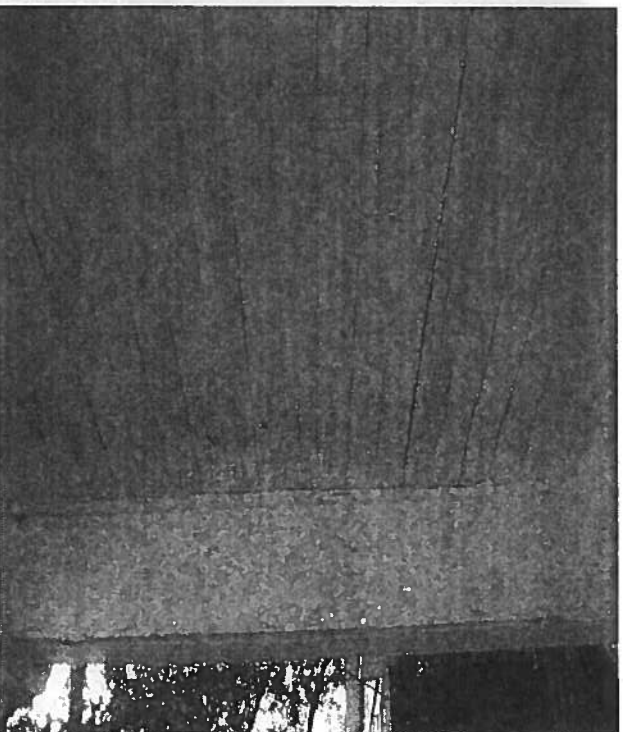
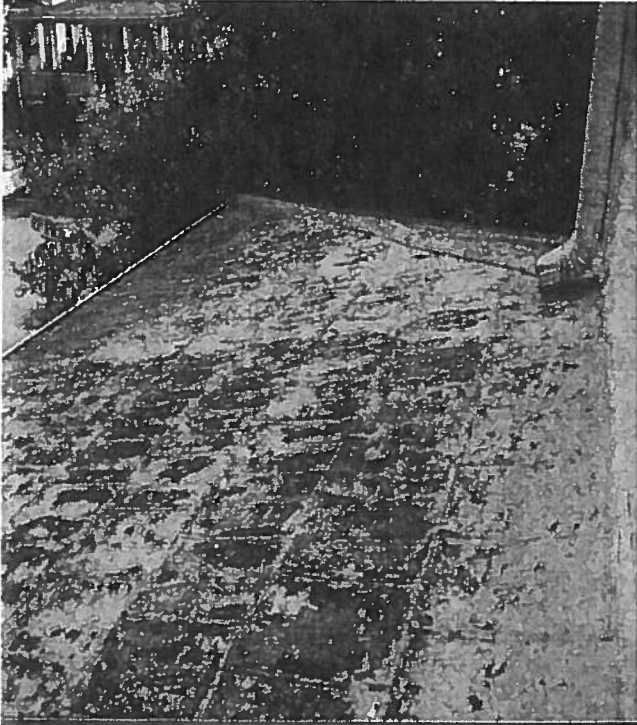
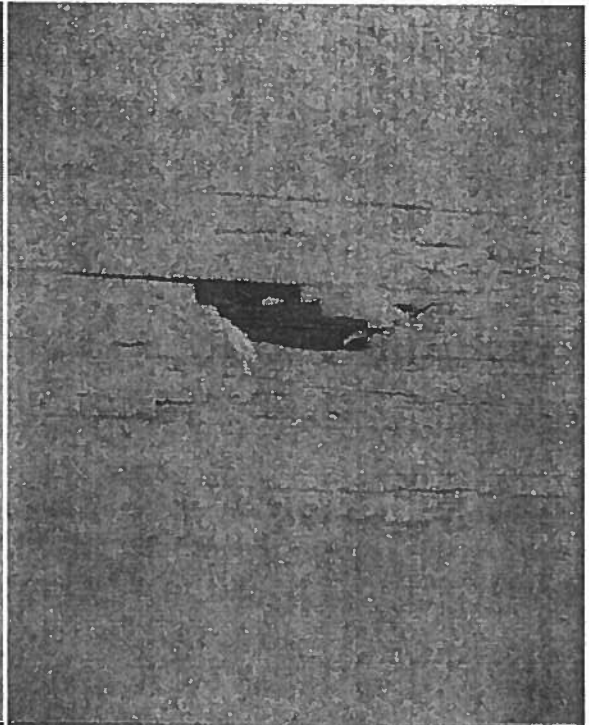
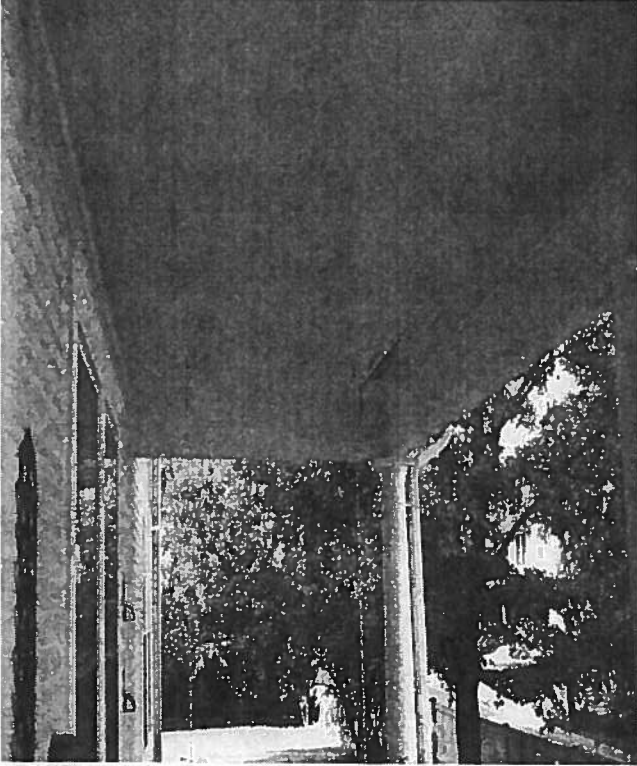
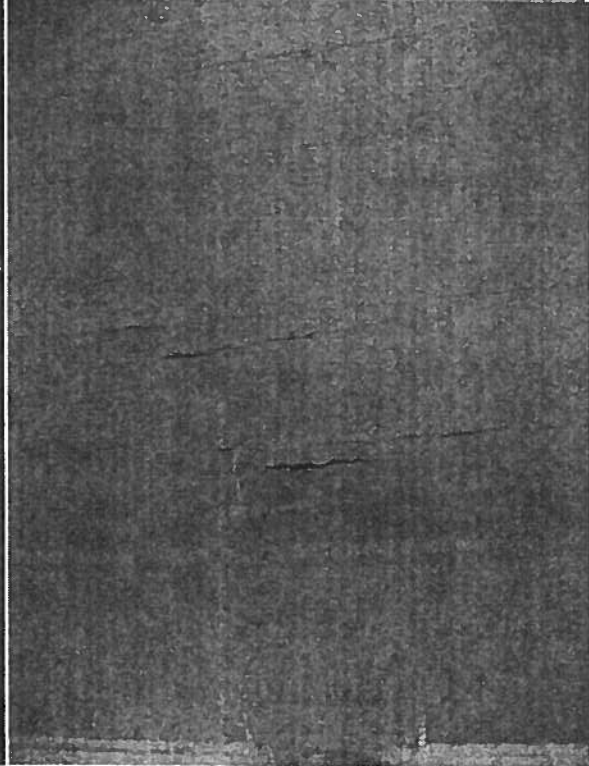
Description: \*FRONT PORCH ONLY\*  
Stamped tin roof circa 1915 is rusted, brittle, and badly leaking. Wood under roof needs to be replaced. Old roof tiles will be replaced with standing seam metal roof, modeled after 3624 21st Ave N front porch roof.

We purchased the home in November 2010 and had planned to rehabilitate the roof in connection with a possible renovation of the main home. There was evidence of prior porch roof leakage, but we were assured that the leaks had been fixed; there has been no leakage since purchase in 2010. The front porch roof leaked severely during Hurricane Irene, in at least two or three places, near the front door, and on the other side of the wraparound porch, near the swing. The bead board ceiling suffered significant water damage, and the paint was torn away by the force of the water in several places.

We have contacted several contractors, including Alpharain, who installed the recent stamped tin roofs in Maywood. Alpharain said that the roof is too old/brittle to be repaired and must be replaced. Additionally, the wood beneath the roof must likely be replaced. Alpharain, as well as other contractors, have recommended that a standing seam metal roof, not stamped tin, be installed because of the flat slope on the roof. Additionally, according to a manufacturer's website <http://www.metalshingle.com/Pages/installation>, a minimum 5/12 is recommended for installing metal roof tiles. Note the pictures show that the deterioration on the front porch roof is much more severe than on the rest of the house, where the slope is much higher.

The house was built in 1915 and used lead coated Victorian Stamped Shingles. This is the original roof and lasts about 80 years if well maintained. It is now 95 years old. When we looked at the shingles on the edge of the roof along the eaves we noted that the tin is paper thin and brittle and is rusting on all edges. These shingles are interlocked on all sides when installed so the fact that you can see loose edges from the ground means that they have come "unlocked" in many places. They cannot be relocked. If you choose to scrape and power wash the existing roof just the foot traffic will do major damage to these brittle tin shingles. Since they are lead coated and lead was taken out of paint in 1978 there is no paint that will adhere to these shingles for over 3 or 4 years. The shingles on the low slope porches have been letting water in for years and we expect to find lots of rot on the purloins once the porch shingles are removed.

We recommend that ice and water shield be installed on all the flat porch roofs and that standing seam panels be installed in these areas. The ARB of Arlington County will usually allow this on roofs where the porch roofs can't be seen from the street.
