ARLINGTON COUNTY, VIRGINIA
HISTORICAL AFFAIRS AND LANDMARK REVIEW BOARD
APPLICATION FOR CERTIFICATE OF APPROPRIATENESS

Name of Historic District _____
Address of Building Maywood
2210 N. Nelson St

ATTACHMENT A

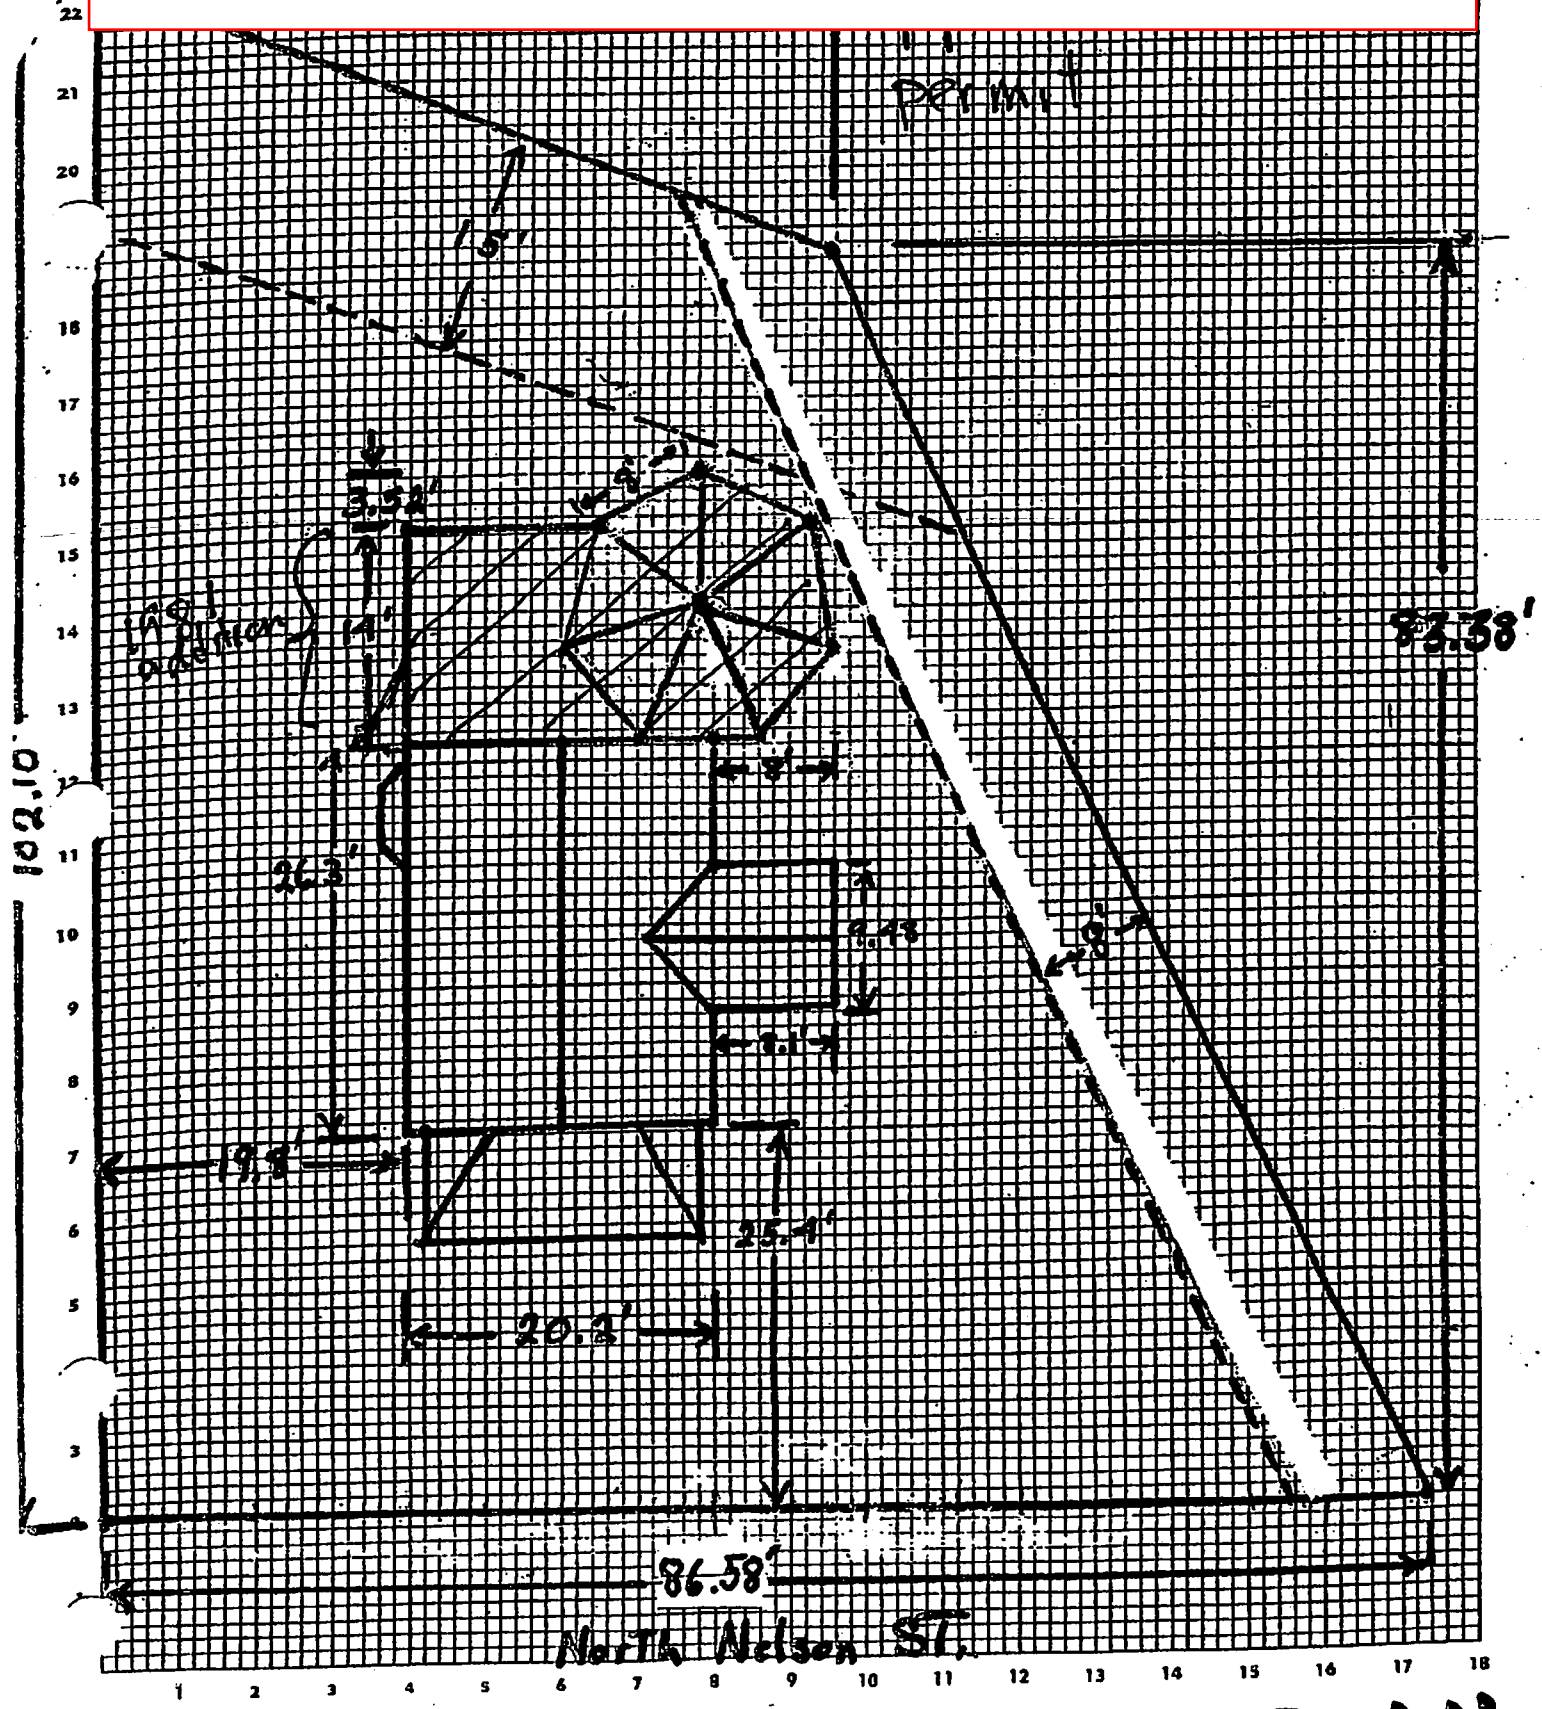
SITE PLAN
(Ent print unapproved)

1981 site plan for heptagonal addition and first and second-story open porch.

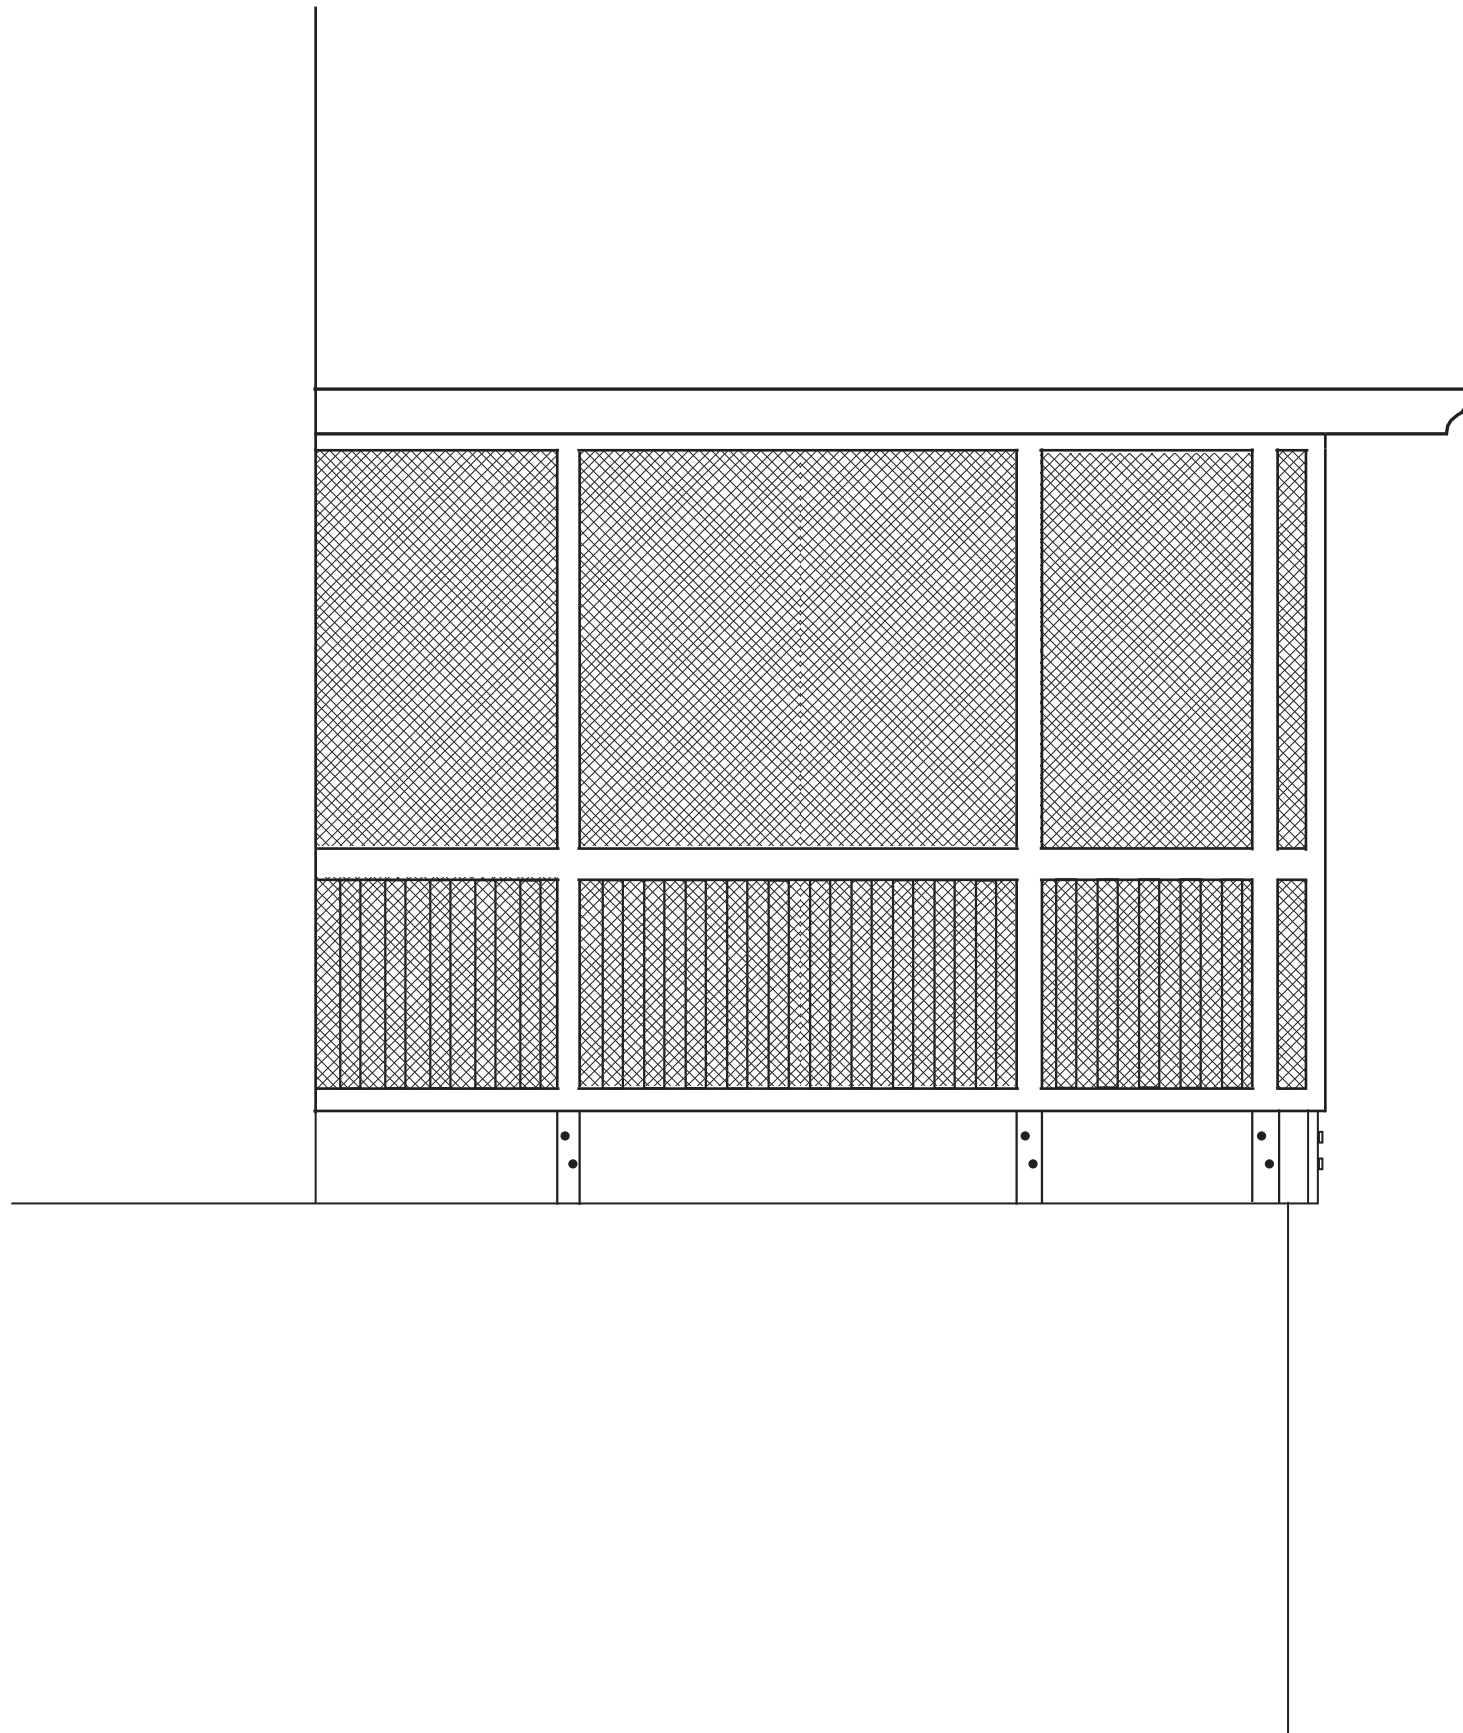
REAR ELEVATION (TYPICAL)

EXISTING (AFTER-THE-FACT)
