Historical Affairs and Landmark Review Board

HALRB Case 17-22A (HP1700043)

CERTIFICATE OF APPROPRIATENESS STAFF REPORT

TO: HALRB
FROM: John Liebertz, Historic Preservation Planner
DATE: September 13, 2017
SUBJECT: 2337 North Fillmore Street, Case 17-22A, Maywood Historic District

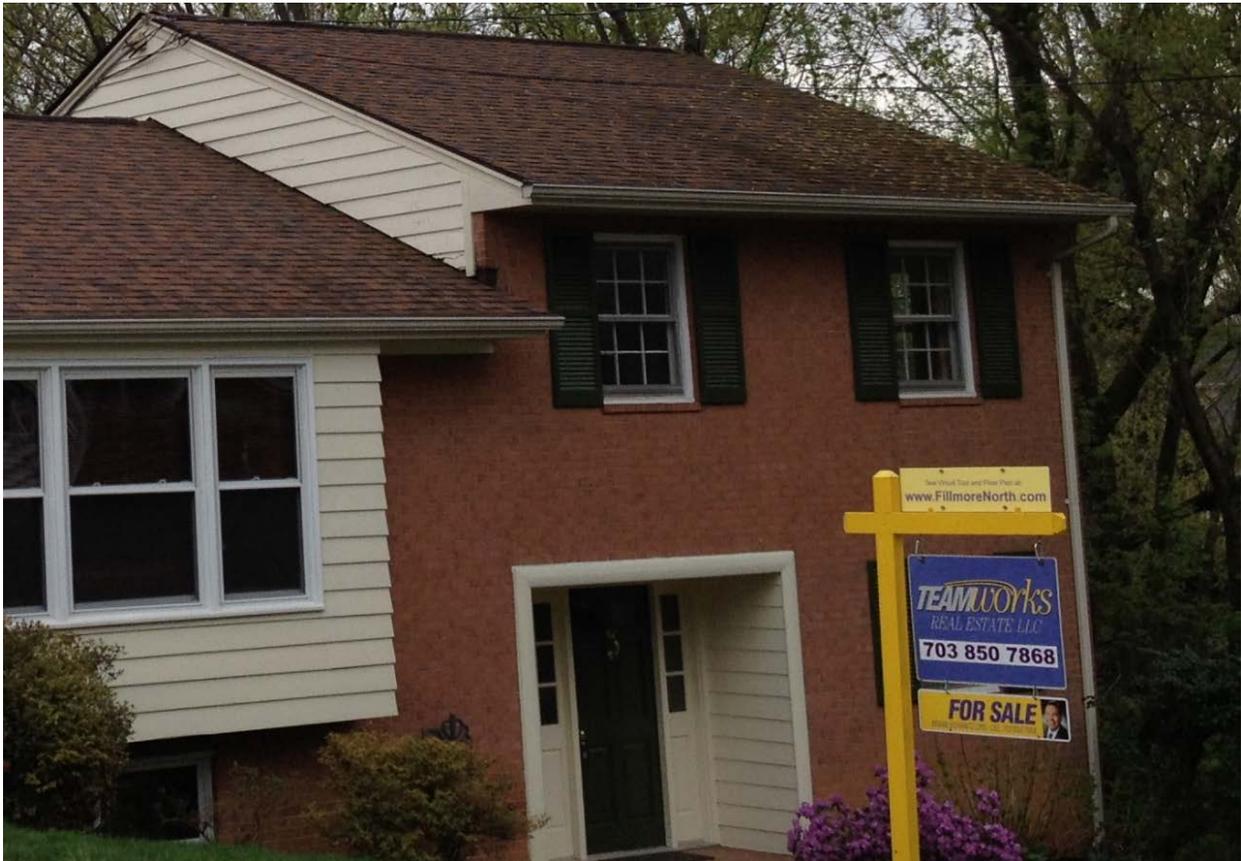
Prior to the window replacement, photographs from 2015 show the original six-over-six, double-hung, wood-sash windows on the two-story section of the dwelling. The picture window likely consisted of later replacement windows based on its appearance.

Figure 1: View of the front elevation of 2337 North Fillmore Street, 2015.

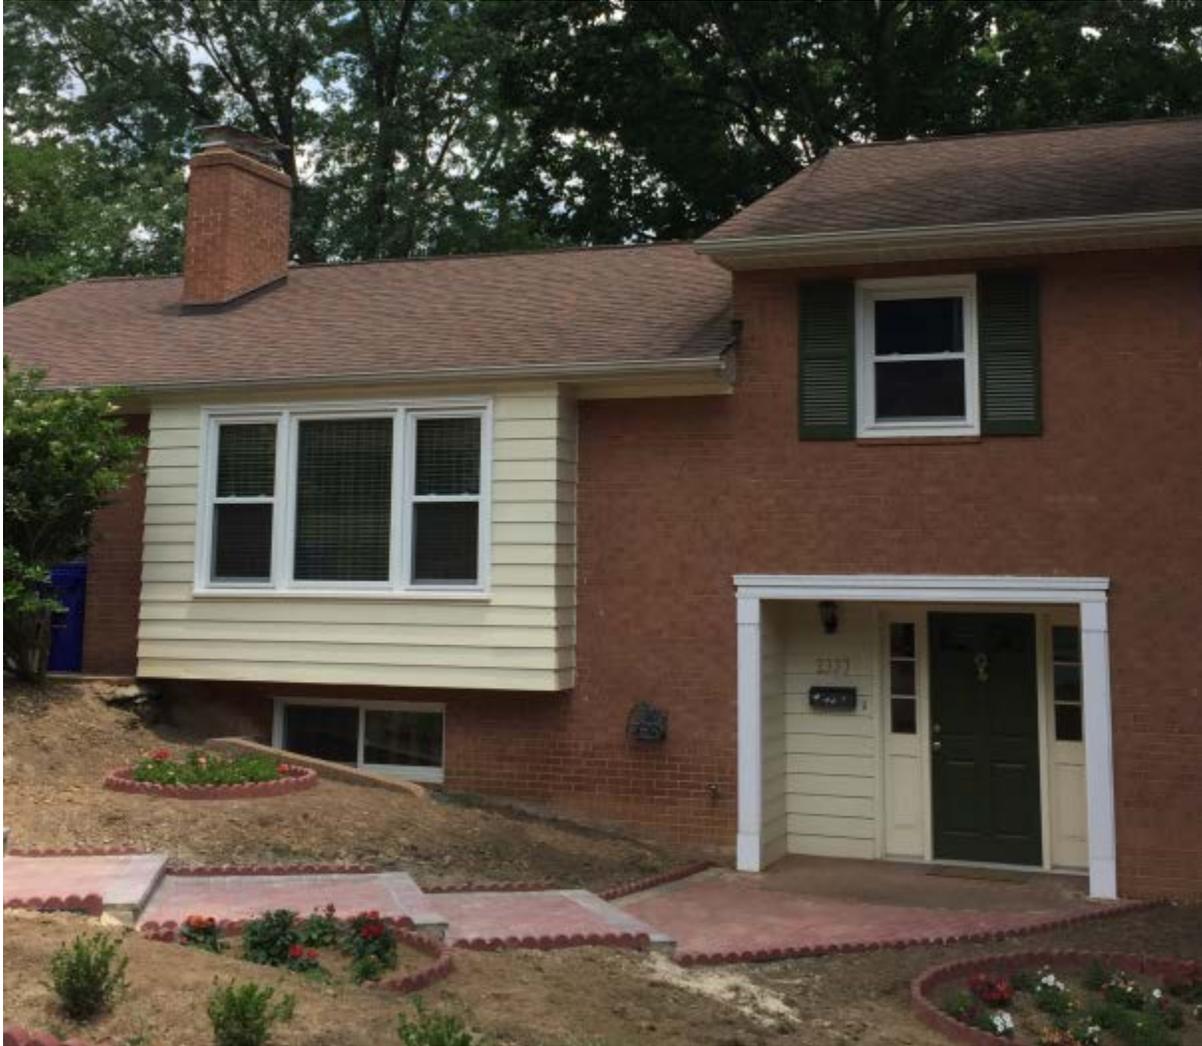
On June 13, 2017, the Historic Preservation Code Inspector noticed completed work on a brick paver pathway at the subject property (see CoA application 17-22). Upon review of the property file, the code inspector noticed that the wood 6/6 windows had been replaced with vinyl 1/1 windows at an unknown date. The inspector issued a notice of violation for both the brick paver pathway and the windows on July 13, 2017, and directed the owner to coordinate with HPP staff on a Certificate of Appropriateness application.

The applicant requests an after-the-fact approval for the replacement of eleven windows with Simonton Reflection vinyl replacement windows. The windows were replaced by the applicant in July 2015.

Figure 2: View of the front elevation of 2337 North Fillmore Street, 2017.

Therefore, the HPP staff recommends denial of the subject proposal as it fails to comply with Chapter 5: Exterior Renovation of the *Maywood Design Guidelines*.
