LETTER OF TRANSMITTAL

To: Arlington County, HALRB
From: Anne Braghetta and Tim Huson, Home owners
RE: Request to implement roof repairs – 2101 North Kenmore St., Maywood

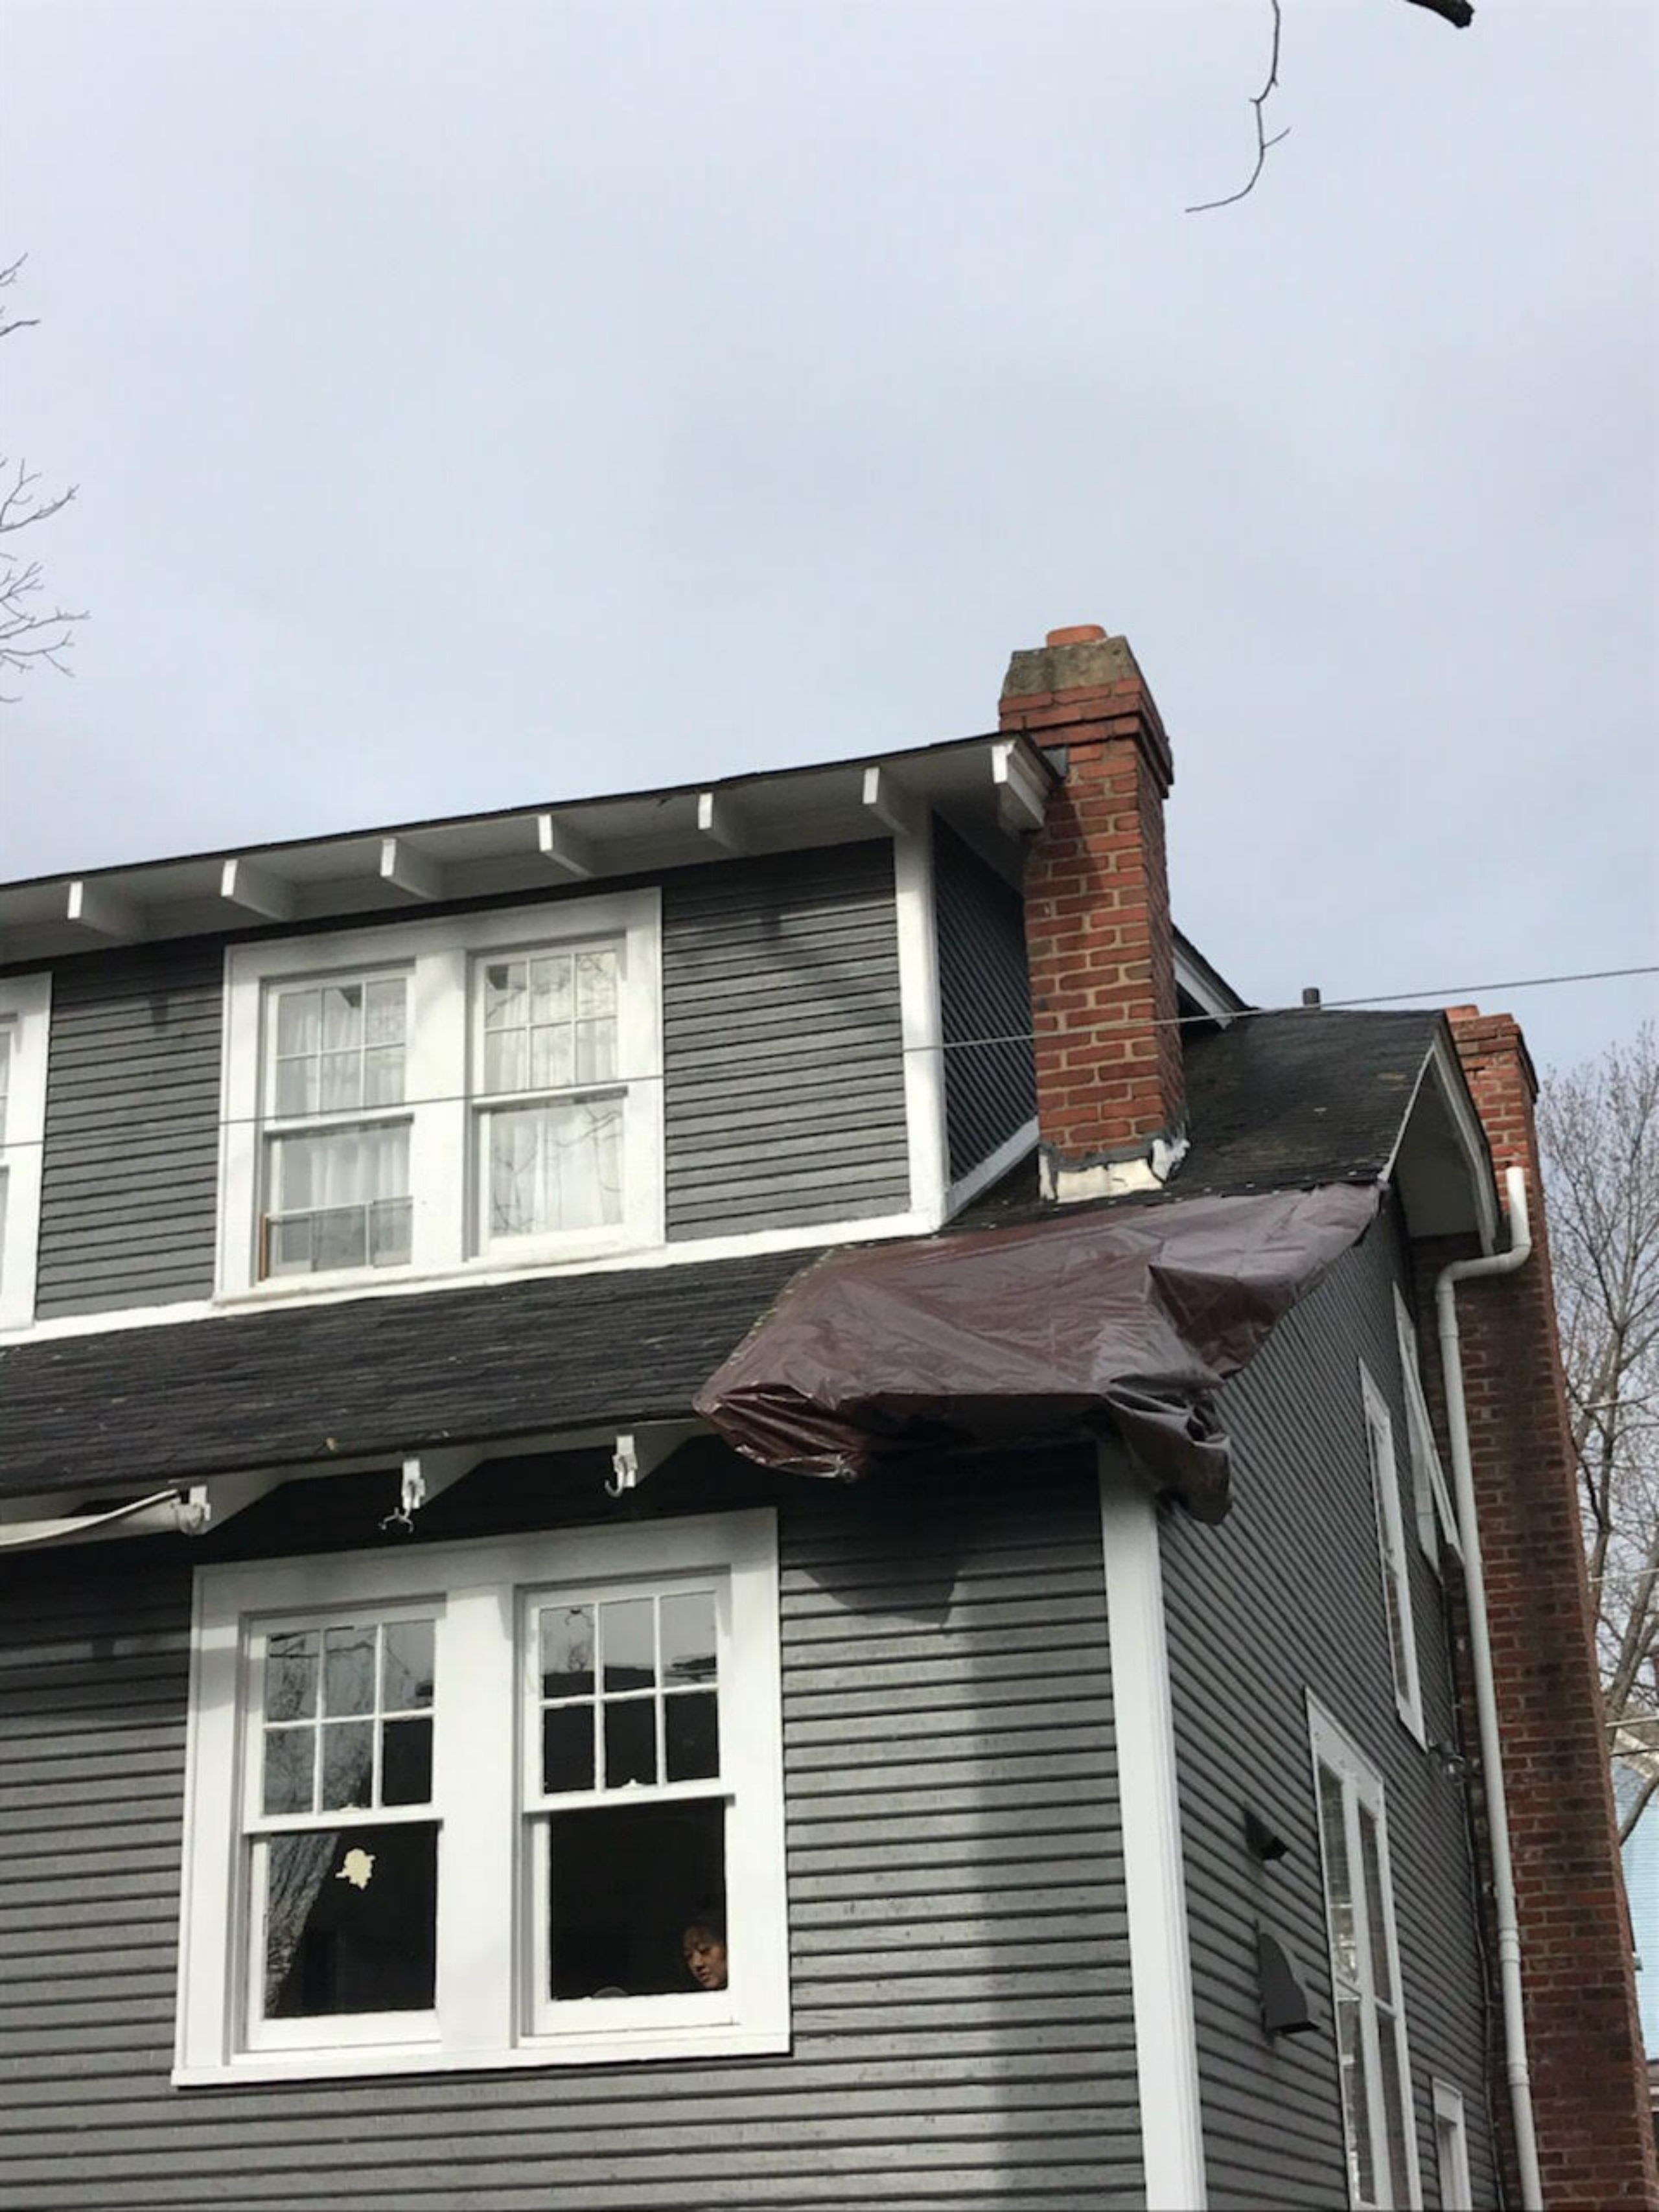
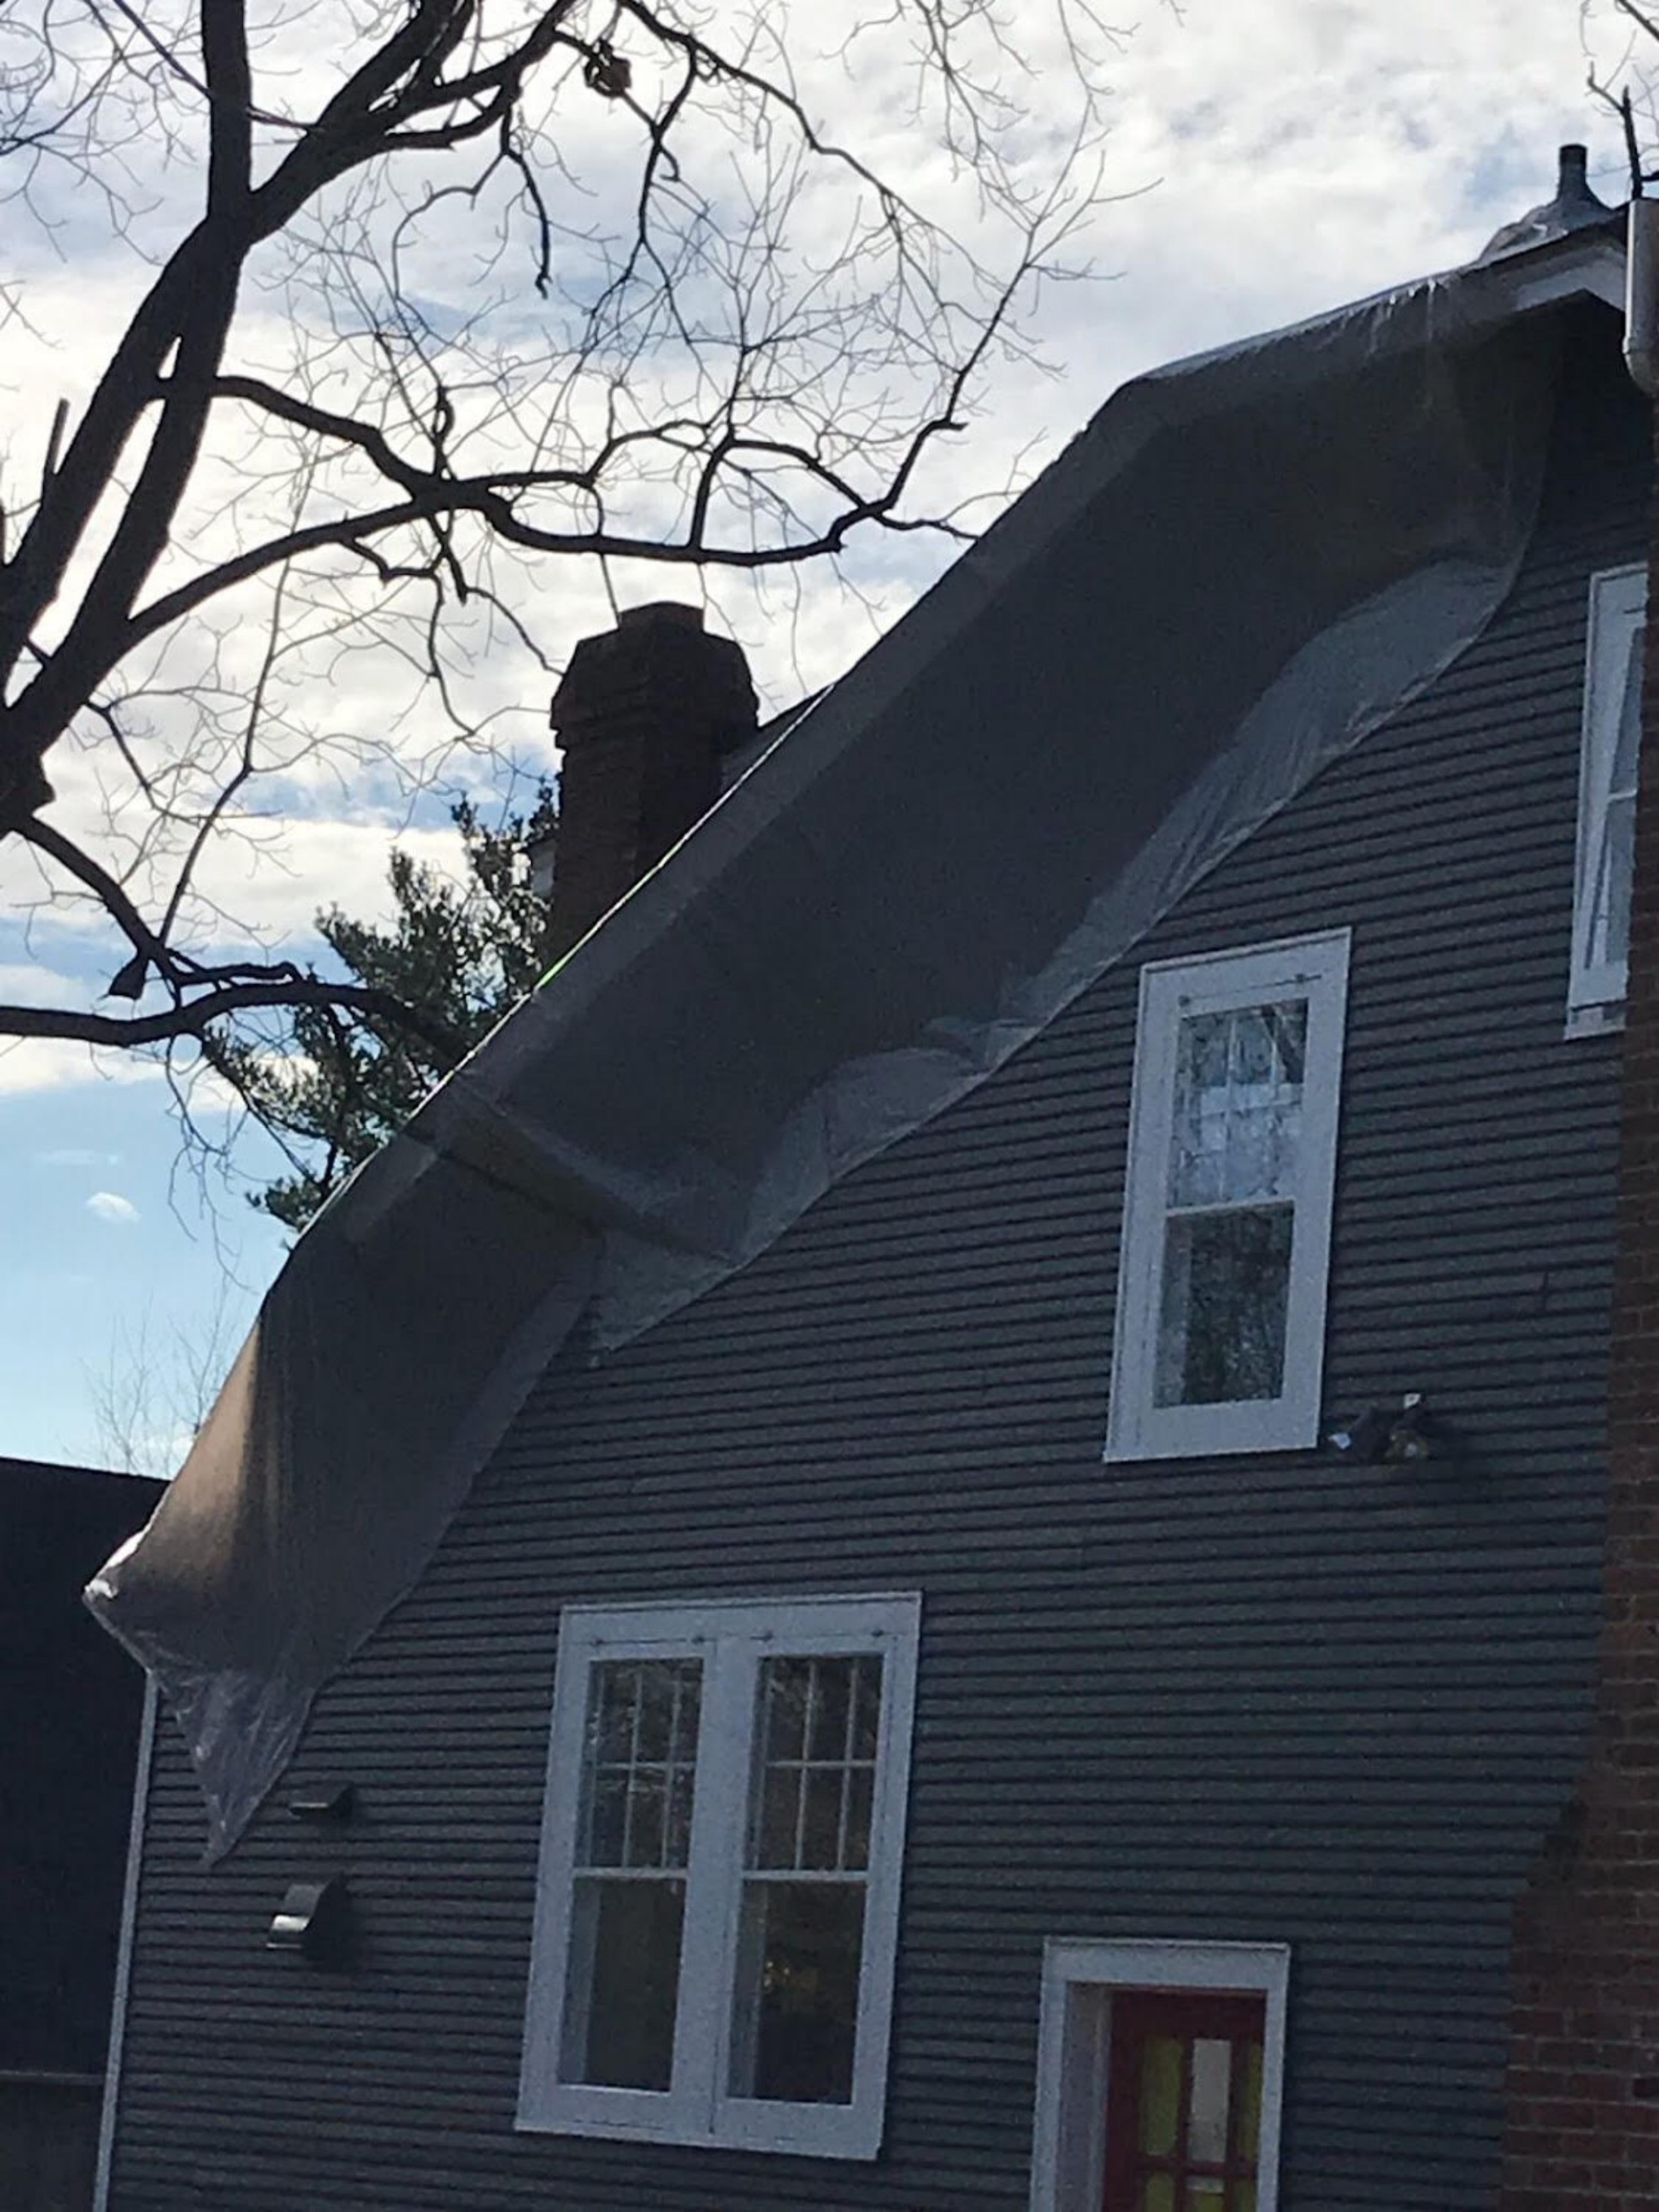
On March 2, 2018, a large pine tree fell on our home in Maywood, 2101 North Kenmore Street. The tree fell on the lower portion of the rear roof eave, damaging the lower eave and soffit. The insurance company evaluation determined that no structural damage occurred. Roof damage caused by the falling tree did however create a separation between the lower roof eave and an unused/disconnected brick flue at the rear of the house. This roofing separation created a leak in the roof. As you can see in photos, the brick flue is in the rear portion of the house that does not face the street. Our contractor and others are recommending that the flue be removed to just below the lower roof level, to eliminate the risk of future roof leakage.

Given that the brick flue is not in use, and is located in a rear portion of the house (not street facing), we believe that removal of this inoperable brick flue is in the best interest of house stability and roof integrity. We believe this flue is not original, but was added subsequent to primary house construction.

We are requesting permission to follow the recommendation of the contractor and others and remove the brick flue to below the lower roof level. Where the brick flue now exits the lower rear roof, the eave would be repaired and the roof would be resurfaced above the flue surface with asphalt shingles identical to the rest of the house. Additionally, the upper, dormer roof above the brick flue would be repaired so that the dormer roof with overhanging eave, rafter, and cornice will match the adjacent roof lines without indication of the previous existence of a flue. In-kind asphalt shingles will also be installed on the dormer roof so that there will be no indication that a brick flue had ever been installed.

Please note that the roof repair materials will be wood and asphalt shingles, equivalent to those currently installed. The profile and details of future in-filled sections of both upper and lower roofs will match the existing profiles, details and materials.
