OVERVIEW OF PROPOSED WORK: CARLIN HALL BUILDING ENVELOPE PROJECT

**ARLINGTON COUNTY, VIRGINIA
HISTORICAL AFFAIRS AND LANDMARK REVIEW BOARD
APPLICATION FOR CERTIFICATE OF APPROPRIATENESS**

Name of Historic District Carlin Community Hall
Address of Building 5711 South 4th Street

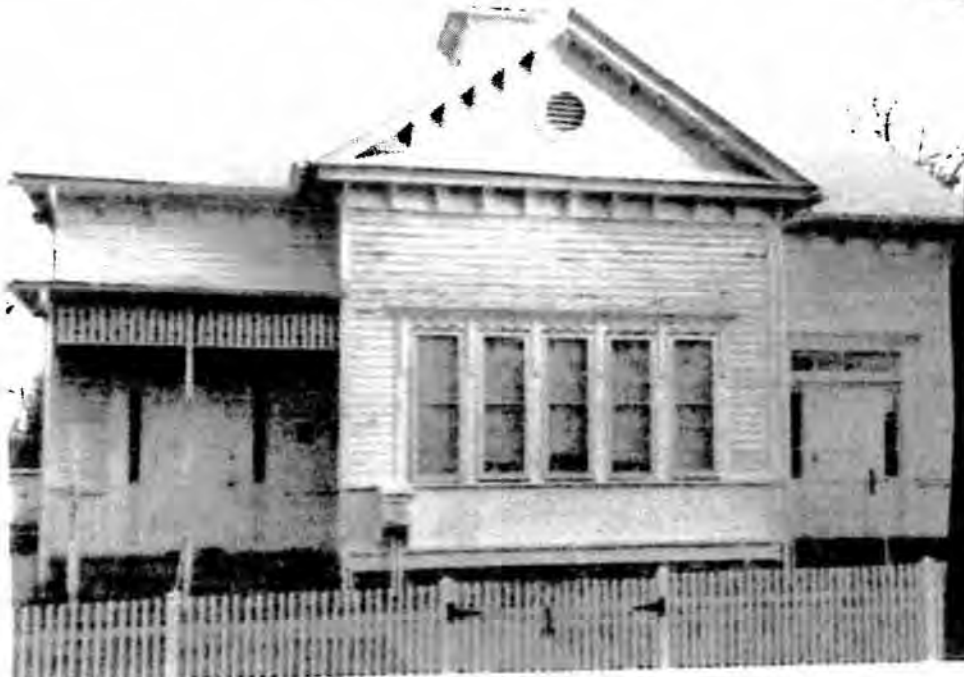
LINE NO.	LOCATION SIZE INFO	BOOK CODE DESCRIPTION	UNIT PRICE	QTY	EXTENDED PRICE
Line- 6	SOUTH ELEVATION	EWD3180			
	Rough Opening: 32 1/8 X 80 3/4	Frame Size : 31 3/8 X 80 (Outside Casing Size: 37 X 85 11/16), Siteline EX Wood Double Hung, Primed Exterior, Pine Primed Interior, 3 1/2" Side/5 1/2" Head Casing, Standard Sill Nosing, Vinyl DripCap, 4 9/16 Jamb, Standard Double Hung, White Jambliner, White Hardware, BetterVue Mesh Brilliant White Screen, DP 35, Insulated Low-E Tempered Glass, Preserve Film, Argon Filled, GlassThick=0.756, Clear Opening: 27.825w, 36.332h, 7.02 sf REV 2011.4.0.378/PDV 5.532 (11/16/11) NQ

Viewed from Exterior. Scale: 1/8" = 1'

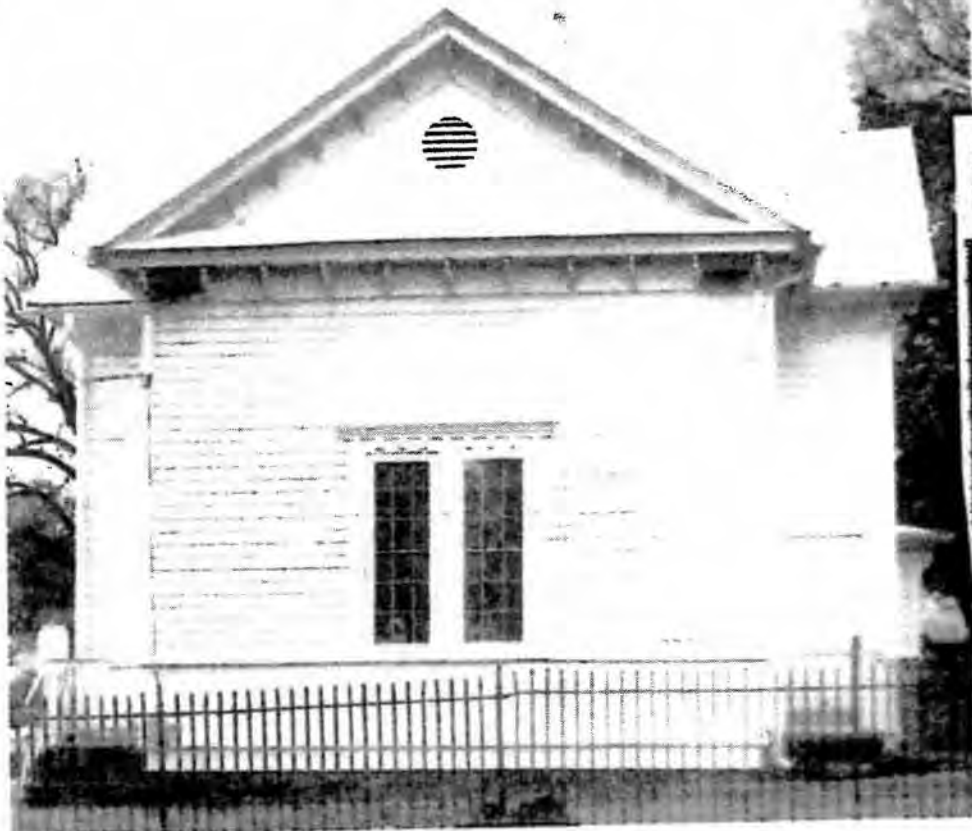
EWD3180
 Frame Size : 31 3/8 X 80
 (Outside Casing Size: 37 X 85 11/16),
 Siltline EX Wood Double Hung,
 Primed Exterior,
 Pine Primed Interior,
 3 1/2" Side/5 1/2" Head Casing, Standard Sill Nosing, Vinyl DripCap,
 4 9/16 Jamb,
 Standard Double Hung, White Jambliner,
 White Hardware,
 BetterVue Mesh Brilliant White Screen,
 DP 35,
 Insulated Low-E Tempered Glass, Preserve Film, Argon Filled,
 GlassThick=0.756, Clear Opening: 27.825w, 36.332h, 7.02 sf
 REV 2011.4.0.378/PDV 5.532 (11/16/11) MQ

RO Size=38 1/2" W x 97 5/8" H
 Unit Size=43 1/4" W x 100" H

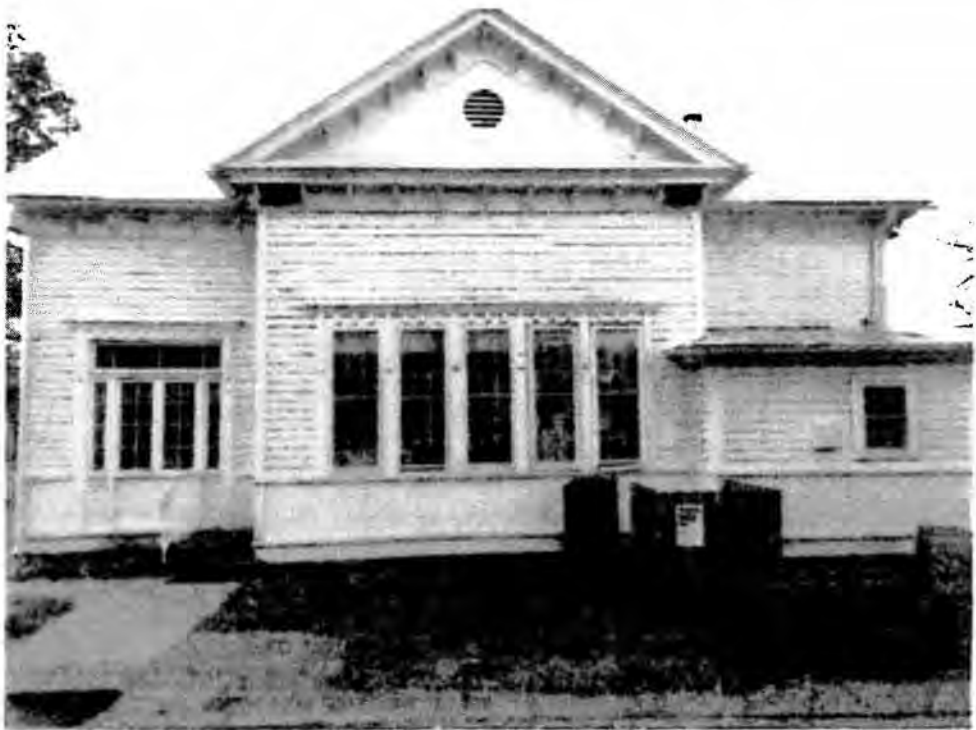
LINE NO.	LOCATION SIZE INFO	BOOK CODE DESCRIPTION	QTY
Line- 1	NORTH ELEVATION Rough Opening: 32 1/8 X 80 3/4	EWD3180 Frame Size : 31 3/8 X 80 (Outside Casing Size: 37 X 85 11/16), Stallone EX Wood Double Hung, Primed Exterior, Pine Primed Interior, 3 1/2" Side/5 1/2" Head Casing, Standard Sill Nosing, Vinyl DripCap, 4 9/16 Jamb, Standard Double Hung, White Jambliner,	5

Viewed from Exterior. Scale: 1/8" = 1'

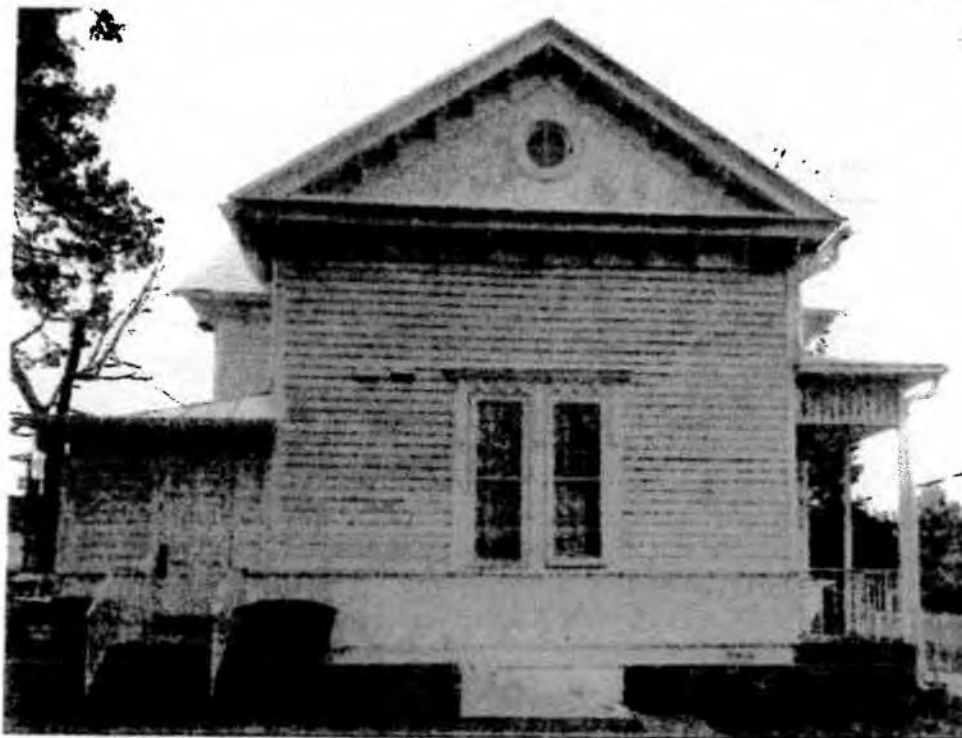
Line- 4 WEST ELEVATION
