# Historical Affairs and Landmark Review Board

HALRB Case 16-01 (HP1600003)

A request by Peter & Yolanda Severs, owners of 2314 North Kenmore Street in the Maywood Neighborhood Historic District, to demolish the existing outbuilding (chicken coop), garage, and deck.

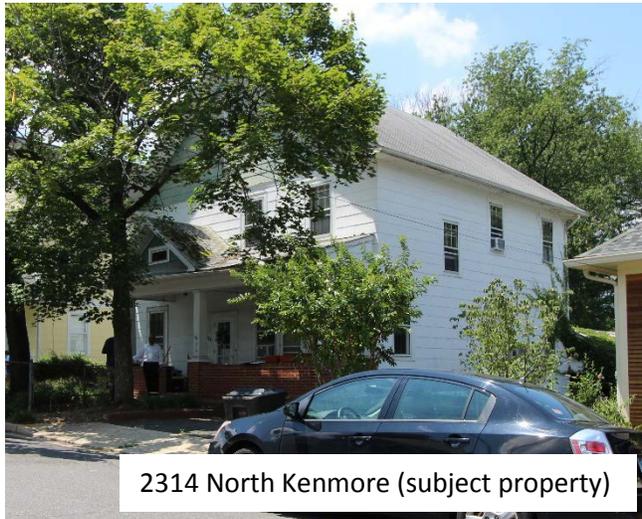
2314 North Kenmore (subject property)

The wood frame dwelling sits on a solid stuccoed foundation and is capped by a front-gabled roof with asphalt shingles. The dwelling, clad in asbestos shingles, measures four bays in width and features a two-bay porch on square posts, overhanging eaves, and six-over-one wood-sash windows. Other details include molded wood surrounds, an exterior-end brick chimney, and a molded wood cornice with gable-returns. The house is said to incorporate a circa 1908 house that was severely damaged by fire.

The house originally matched the design of the adjacent house at 2318 North Kenmore Street (see comparison on next page). Additions to the subject house consisted of extending the building one-bay to the north, adding a second story, extending the roof over the one-bay front porch addition, and connecting the garage to the house.
