**Design Guidelines for a Certificate of Appropriateness
and an Administrative Certificate of Appropriateness for the
Fraber House at 1612 North Quincy Street,
a Local Arlington County Historic District**

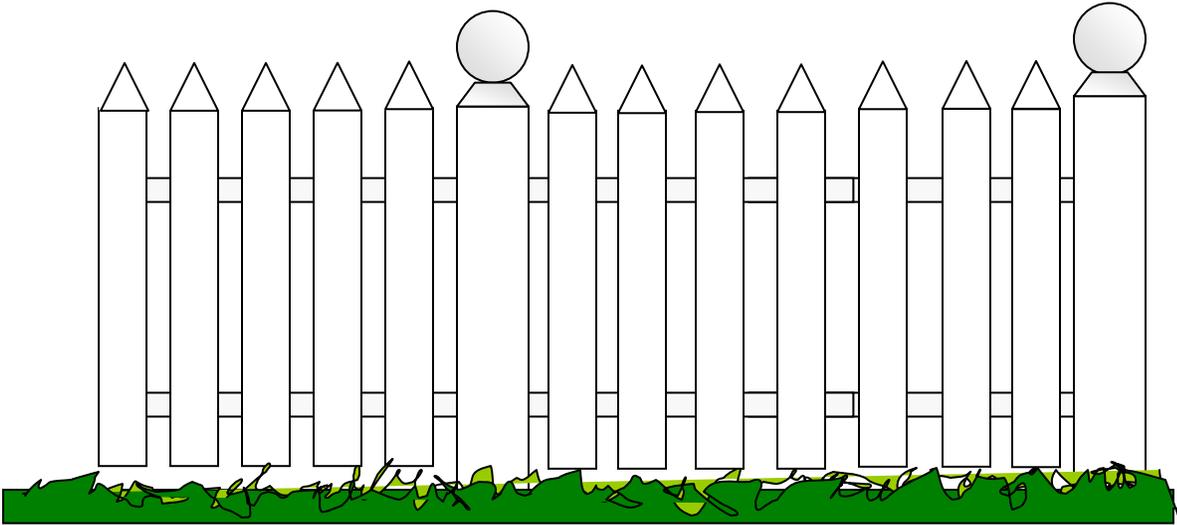
Figure 1: Example of a Gothic Wood Picket Fence.

Picket fences are defined as wood fences consisting of boards vertical in orientation, with spaces between the vertical boards (See Figure 1 above). The installation of picket fences may be approved under the ACoA process for placement in front, back, or side yards provided that the fence design is one of those shown in Figure 2 below. The setbacks and heights of fencing also must comply with relevant Arlington County Codes and Ordinances, Section 32, D3a/e.

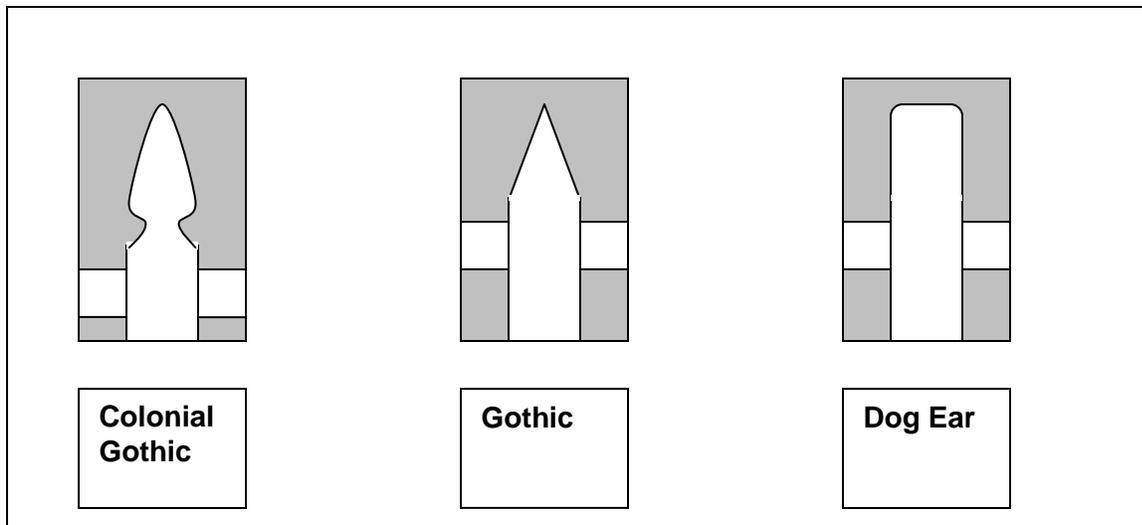
Figure 2: Wood Picket Fence Types Approved under ACoA Process.
